# Limited Hazardous Materials Assessment Island Savings Centre – 2687 James Street, Duncan, BC

**Project #:** 33064

Cowichan Valley Regional District

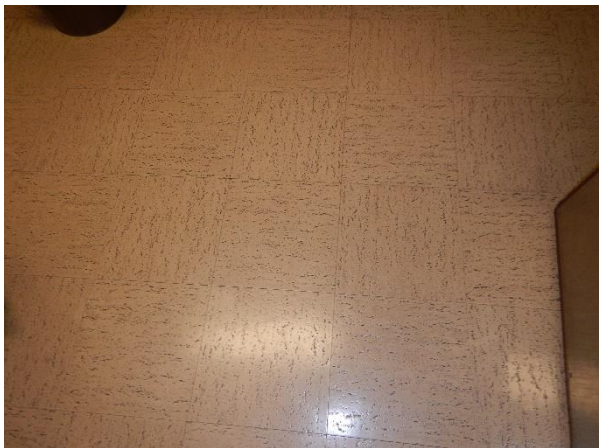
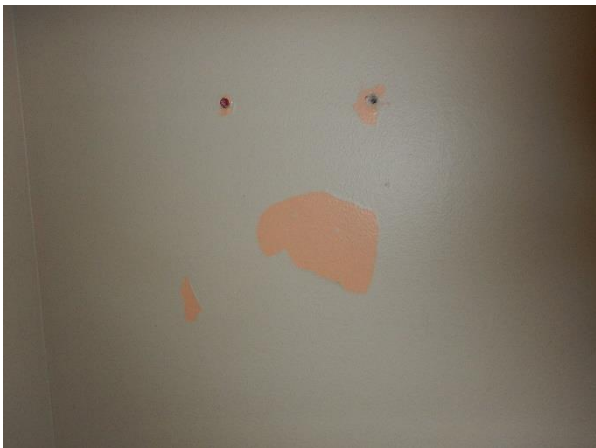
<b>Sample: N/A</b> <b>Location: Handicap washroom</b> <b>Description: Floor tile – 12" x 12" beige with dots</b> <b>Hazardous Material: Client reported that the floor tile was asbestos containing.</b>	<b>Sample: 33064-22</b> <b>Location: Handicap washroom</b> <b>Description: Light green paint on drywall</b> <b>Hazardous Material: 20,000 mg/kg lead</b>

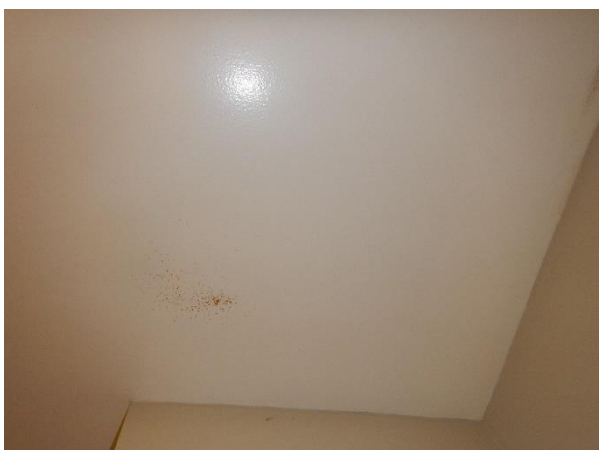
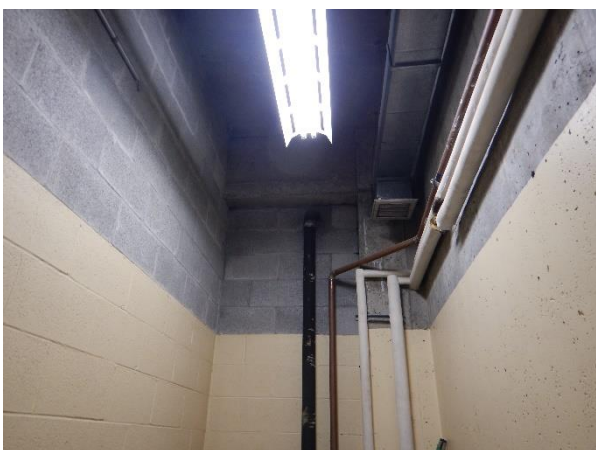
<b>Sample: 33064-23</b> <b>Location: Handicap washroom</b> <b>Description: White paint on drywall</b> <b>Hazardous Material: 30,000 mg/kg lead</b>	<b>Sample: 33064-24</b> <b>Location: Janitor's closet</b> <b>Description: Yellow paint on concrete block</b> <b>Hazardous Material: 740 mg/kg lead</b>

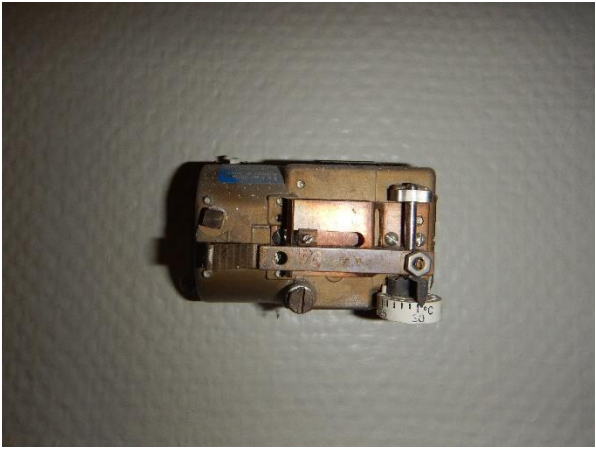
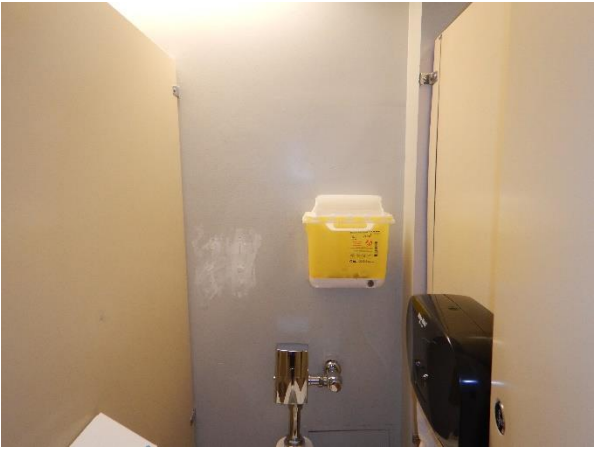
<p>Sample: N/A Location: Main hallway Description: thermostat Hazardous Material: <b>May contain mercury</b></p>	<p>Sample: N/A Location: Women's washroom Description: Biohazards box Hazardous Material: <b>Biological hazards</b></p>

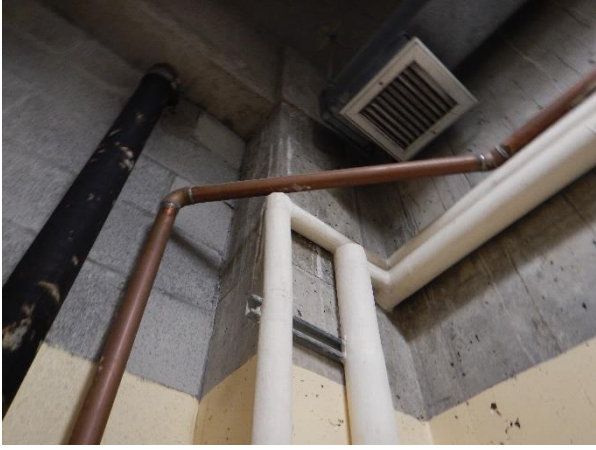
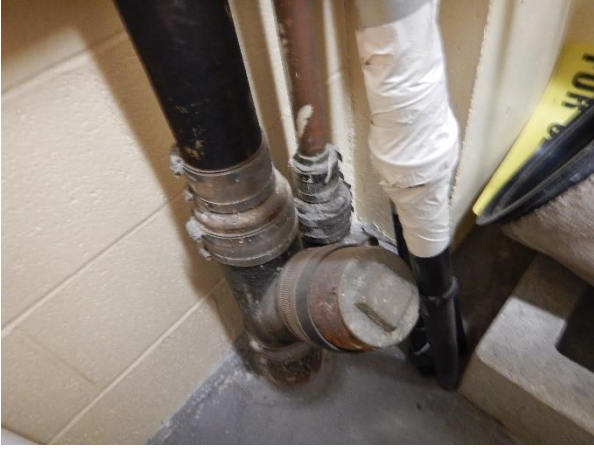
<p>Sample: N/A Location: Janitor's closet Description: Copper pipe Hazardous Material: <b>Elemental lead solder on copper pipes</b></p>	<p>Sample: N/A Location: Janitor's closet Description: Bell and spigot pipe Hazardous Material: <b>May contain lead. May contain asbestos.</b></p>

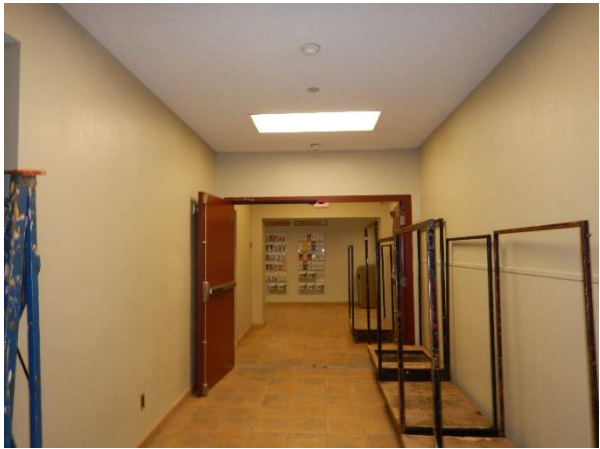
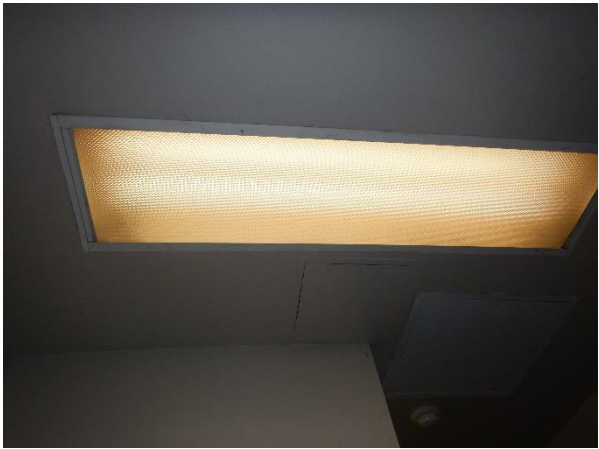
<p>Sample: N/A Location: Hallway Description: Smoke detector Hazardous Material: <b>Contains radioactive materials</b></p>	<p>Sample: N/A Location: Handicap washroom Description: Fluorescent lights Hazardous Material: <b>Fluorescent light tubes contain mercury vapour. Fluorescent light ballasts may contain PCBs</b></p>
