> Environmental Impact Assessment Shawnigan Lake – 1160 Stonecrest Way

At the request of the Cowichan Valley Regional District (CVRD), a site visit was completed in the fall of 2019 by Cascadia Biological Services to identify potential riparian/wildlife setbacks for a proposed/existing soil dump site located in the District. The Environmental Assessment is required as the proposed works including the removal of timber/logging debris as well as ongoing soil deposits require setbacks from waterbodies and/or rare elements (if located). The setbacks are variable depending on the waterbody/attribute in question whether it is a ditch, a seasonal creek, wetland, lake, wildlife tree, rare species of plant/wildlife etc. Please refer to Attachment I identifying the proposed study area within the confines of the parent property. The proposed study area measures approximately 4.63 hectares and is presented at different overview levels in Attachment(s) 1a-1b. Attachment II presents the proposed fill site area boundary within the subject property. This area measures approximately 2.86 hectares. A map showing the potential for environmental sensitive species is shown in Attachment III in referen

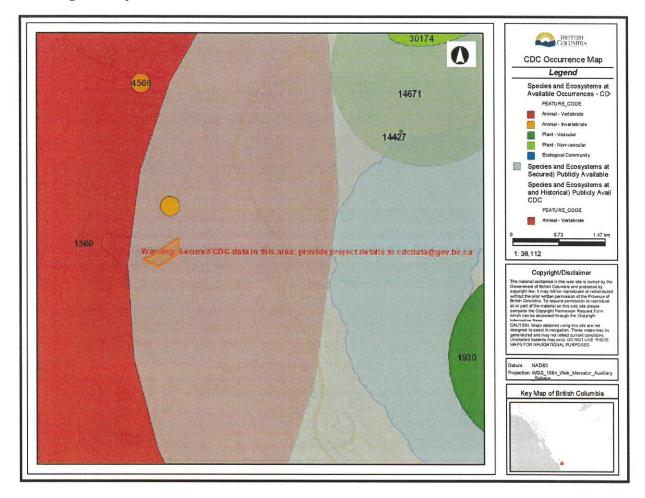
Attachment III – Environmentally Sensitive Attributes within 500m of the Study Area Designated by the BC Conservation Data Centre

Note: Red polygon (circle) represents the potential and historic occurrences of Ermine Anguinae (short-tailed weasel). Small orange circle polygon immediately north of the site represents the Dun Skipper (invertebrate animal) documented occurrence.
